## Factors Affecting Flash Flood Disaster in Ghat Town in Libya

**Objectives:** The research aimed to remove the ambiguity about the reasons that led to the occurrence of the flood disaster in Ghat town in June 2019 and to identify the factors that influenced its occurrence.

During the first third of June 2019, Ghat town was swept away by flash flood water caused by a rainstorm that lasted for about ten days. This water inundated most of the town's neighborhoods and caused severe damage to the residents and their property.

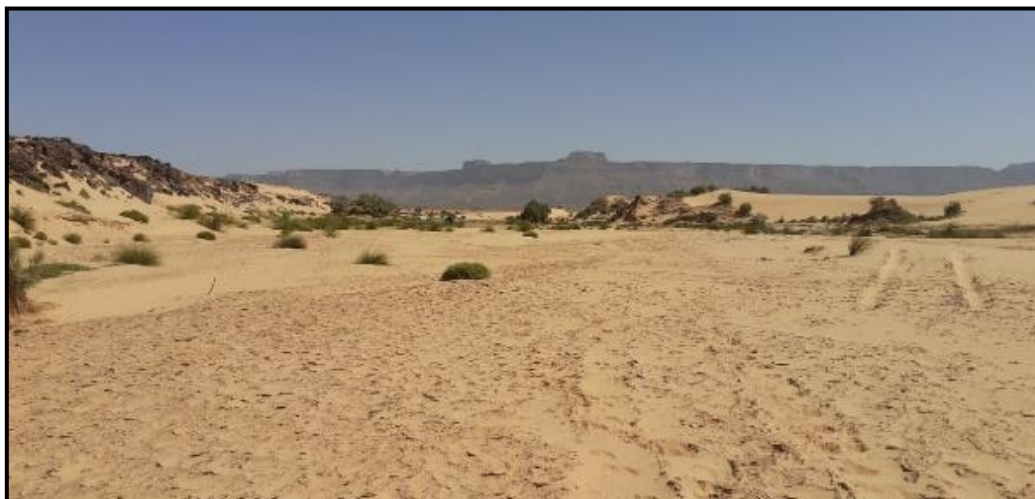
- 3- Quaternary deposits, represented in old and recent wadi deposits, colluvial deposits, sabkhas, and water-eolian deposits. These deposits are found in depressions and wadi bottoms, and most of them have high permeability, except for sabkha deposits, which consist of fine particles of clay and sand mixed with salt. Most of the runoff in the area is shed to sabkhas, creating some ponds that evaporate completely after a short time, leaving behind the salts that accumulate constantly (Figure 4).

**Figure 4: Quaternary deposits covering the bottom of the Wadi Tanezzuft, south of Al-Barket**

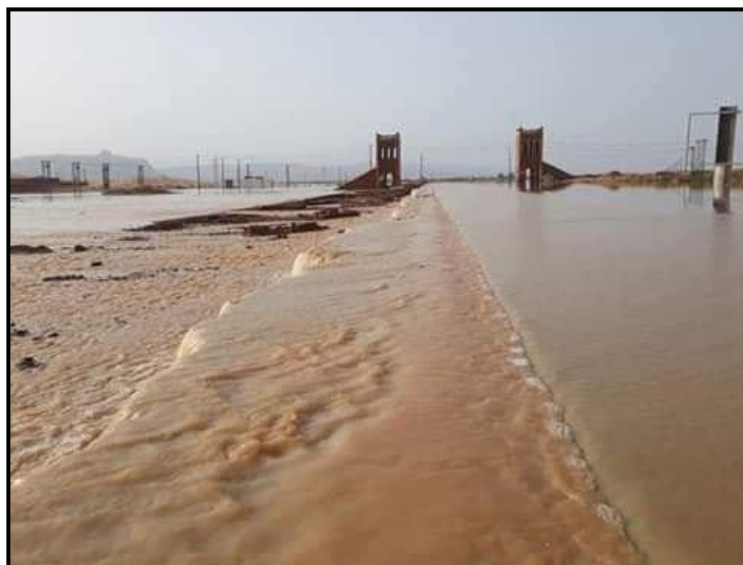
- 2- The western direction, as Wadi Tahramet - Azzezger enters the town from the northwest. Before runoff water enters the town from this direction, it is noted that it spreads widely at the bottom of this flat wadi, so water does not enter the town from one point, but enters it in the form of a sheet flood along the road out of the town towards the north as shown in figure 8. Two small valleys follow this direction, coming from the north, as detailed below.
- 3- The northern direction, which is the least important, due to the small basin areas of the wadis descending from it. They are wadis descending from the area around Ghat International Airport and heading south in two small courses that flow into Wadi Tahramet Azzezger, and they enter the town from its northern gate with the water coming from the west.

**Figure 8: The entry of water from the western direction of Ghat town in the form of a sheet flood**

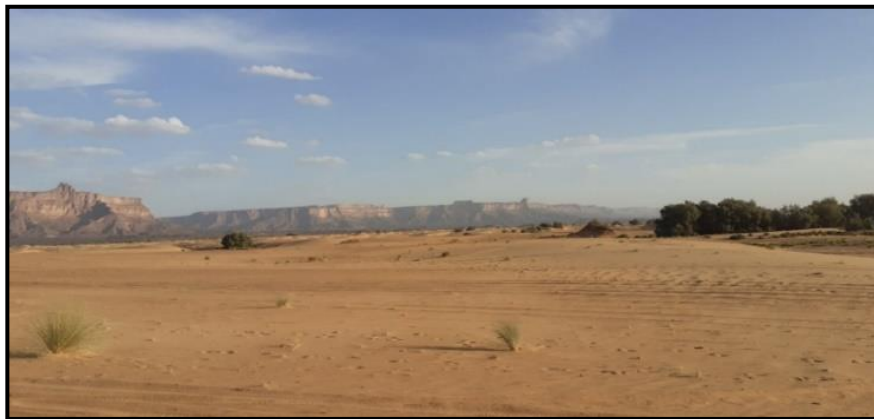
After a gradual drought that started nearly ten thousand years ago (Al-Hakim 1997), the sand began to invade the area and formed a relatively high barrier to the east of Ghat town (Figure 11). This sand blocked the exit of Wadi Tahramet Azzezger, towards the east, leading to the formation of a lake in the location of the current modern town of Ghat. Although the aforementioned lake began to shrink gradually until it dried totally in the last centuries leaving a marshland (sabkha), it continues to turn into a temporary lake when sufficient rain falls on the region.

As the drought became more and more severe, the lake occurrence became rare, so the recent inhabitants of Ghat town may do not remember that situation during their lifetime. Maybe that is why they began to build their houses in the lowlands although it is noted that their ancestors were more careful. The ancient people did not dare to live in the spillway, so you find all the old neighborhoods were built on hill slopes overlooking the spillway, such as the hill called locally (Mount Kokmen) on which the ancient Ghat was established and later expanded in the neighborhood of Tonin and the neighborhood of Tadamet near the old town.

**Figure 11: The eastern sand sheet that separates Ghat town from Wadi Tanezzuft**

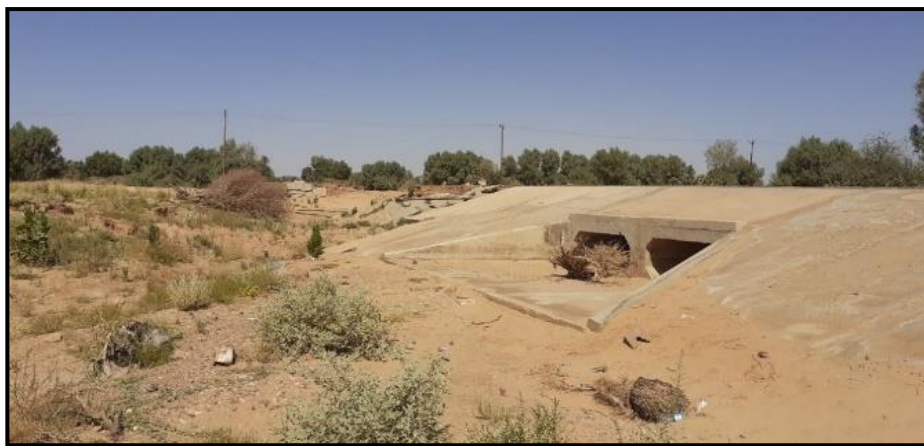
- 3- Many of the goods in the shops that were subjected to submerging during the period of the floods were damaged or completely lost.
- 4- The paved roads were completely or partially destroyed in the locations of the intersection between Wadis and these roads, as in Ghat - Al-Barket road, where Wadi Tanezzuft destroyed the road in two points, one of which contained relatively large hollows to drain water beneath it, but it could not bear the huge quantity of water that time. (Figure 12). The Ghat - Tahala road in the north was also severely damaged, especially near the northern entrance of the town. In other parts, the road holes increased in number and expanded in diameter.

**Figure 12: The destruction of Ghat - Al-Barket road**

The author recommends researching strategies to protect Ghat and its surrounds from future floods by preventing any new construction in flood channels and their natural spillways, as well as strengthening the town's infrastructure for rainwater drainage.
